In the
Supreme Court of the United States

STATE OF FLORIDA,

STATE OF GEORGIA,

**UPDATED PRE-FILED DIRECT TESTIMONY OF FLORIDA WITNESS
THEODORE SCOTT HOEHN**

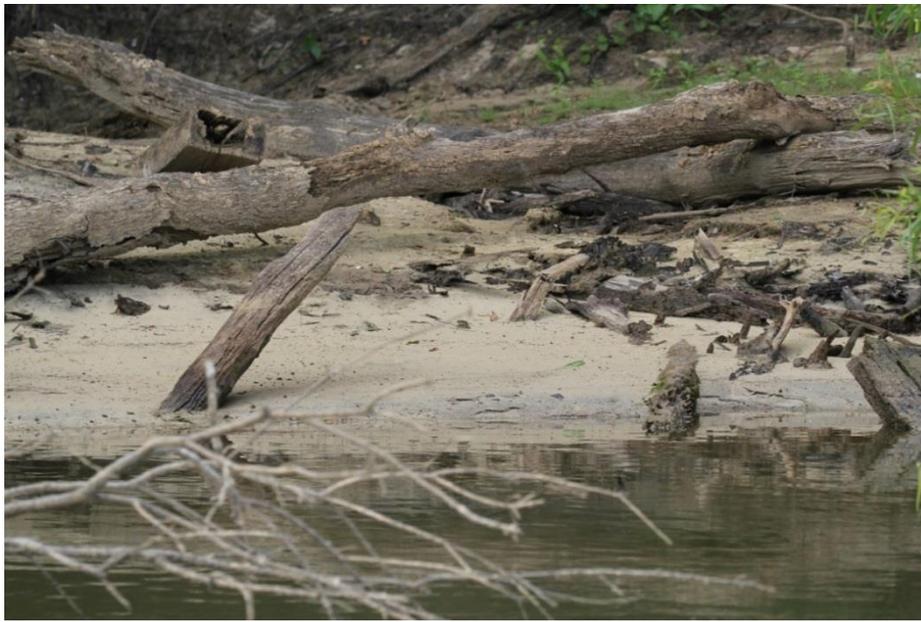
Channel margin habitat at Hog Slough in the Lower Reach, near River Mile 40. This is a true and correct copy of a photo taken on August 2, 2016, during a river trip I attended. I was present when this photo was taken, and it accurately represents conditions at Hog Slough on that day when river flow was approximately 6,500 cfs as measured at the Chattahoochee gage on the Apalachicola River. (FX-812m).
